## Advances in Biological In-Situ Remediation: Full Scale Applications in the Netherlands

NORDROCS, September 20-21, 2006, Malmö  
First joint Nordic Meeting on Remediation of Contaminated Sites

## Case 1: Total Concept Evenblij at Hoogeveen site and Almelo site

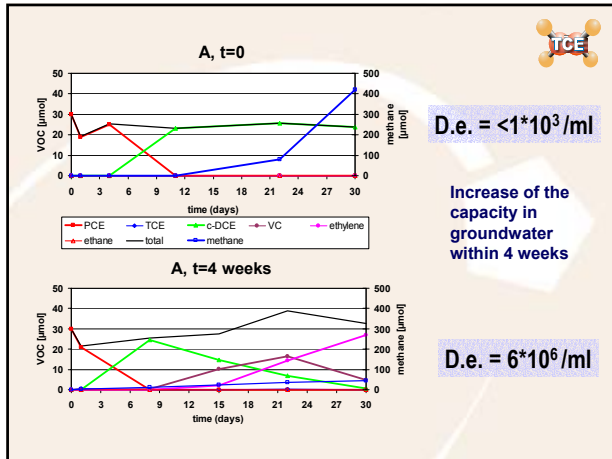
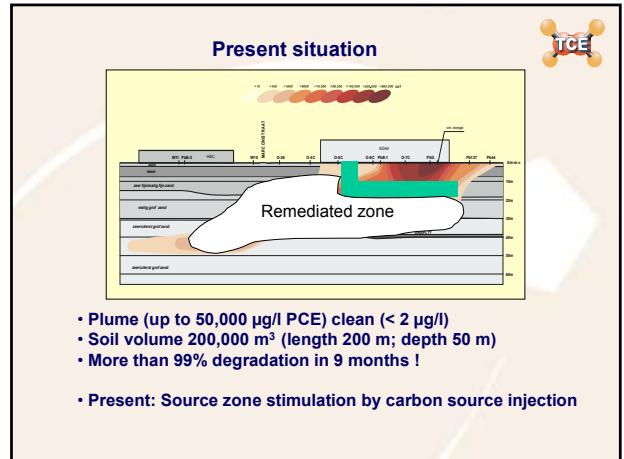
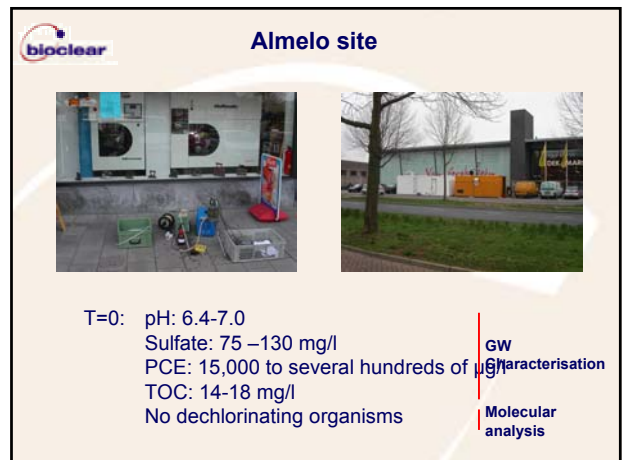
Transfer of degradation capacity from  
bioreactor to the soil:  
Infiltration of organisms

Full scale dechlorinating  
bioreactors

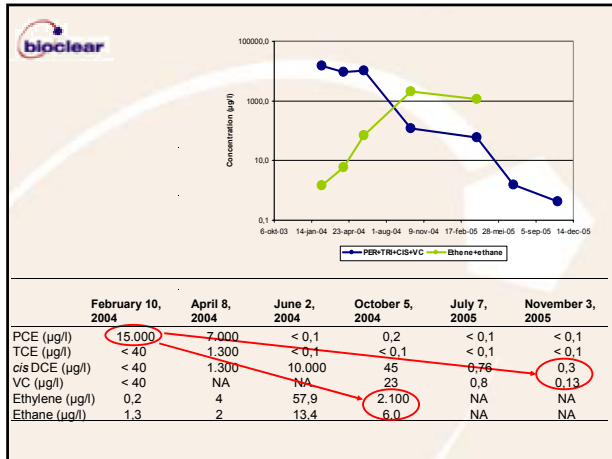
February 10, 2004	April 8, 2004	June 2, 2004	October 5, 2004	July 7, 2005	November 3, 2005
PCE (µg/l)	15,000	7,000	< 0.1	0.2	< 0.1	< 0.1
TCE (µg/l)	< 40	1,300	< 0.1	< 0.1	< 0.1	< 0.1
cisDCE (µg/l)	< 40	1,300	10,000	45	0.76	0.3
VC (µg/l)	< 40	NA	NA	23	0.8	0.13
Ethylene (µg/l)	0.2	4	57.9	2,100	NA	NA
Ethane (µg/l)	1.3	2	13.4	6.0	NA	NA

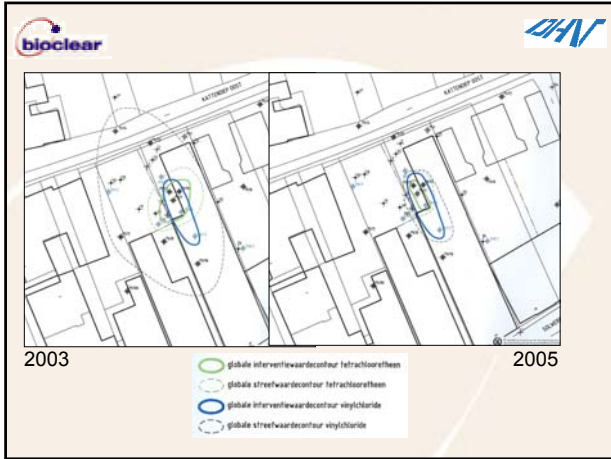
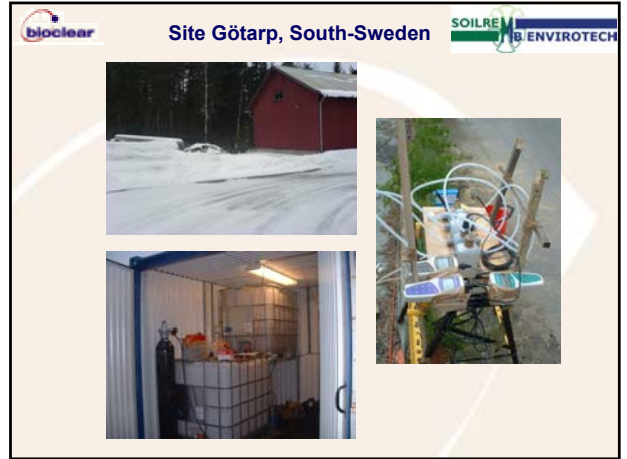
Change in redox conditions,  
necessary for dechlorination

T=0 situation

6 months after start up
