Monitoring Remediation of Mercury Contaminated Sediments in Lake Turingen (Sweden)

Andrew M. Petsonk, WSP Environmental
Ronald Bergman, Municipality of Södertälje

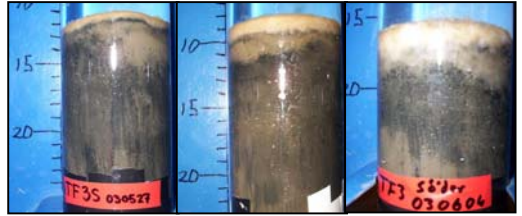
Scale in cm

Core samples from test area

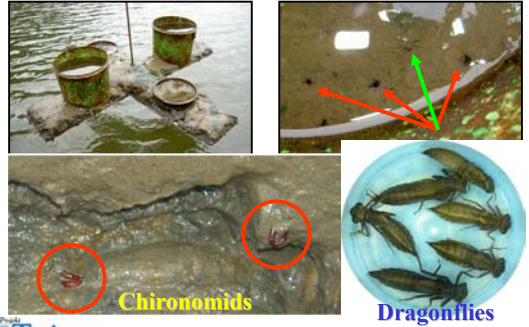
Recolonization by benthic fauna
