Polluted sediments in Bjørvika – the submerged tunnel project

Aud Helland

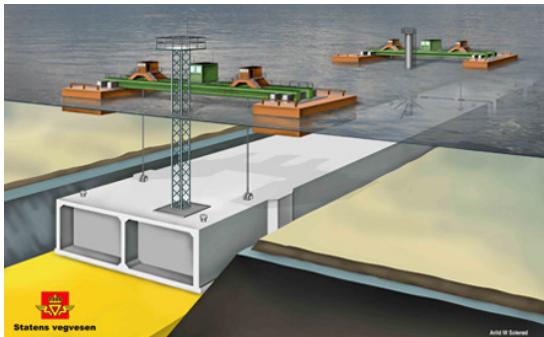
Tunnel elements

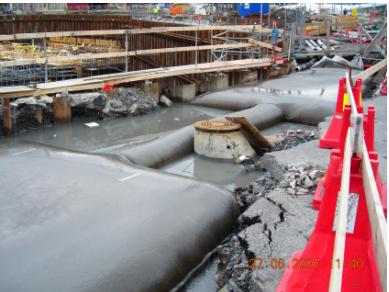
Dreding and filtration of water
